## REVITALIZATION OF THE “VARADINSKA DUGA” BRIDGE

## 2. Varadin Bridge

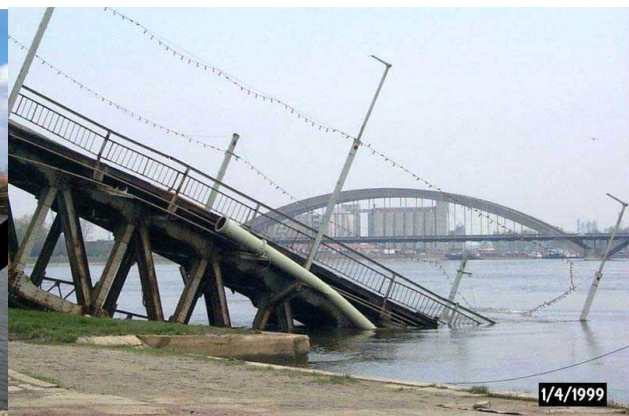
Fig. 2 Varadin Bridge on April 1<sup>st</sup>, 1999  
(Zezelj's bridge is seen in the background)

The “Varadin Bridge” was the first bridge struck by the bombs. It was destroyed at 4:55 on April 1<sup>st</sup>, 1999. The bridge was built over the Danube in the southern part of Novi Sad where the river angularly changes its direction. Later, it was realized that its height was insufficient for the demands of modern shipping prerequisites, but the “Varadin Bridge” was inevitable part of the panorama of Novi Sad.

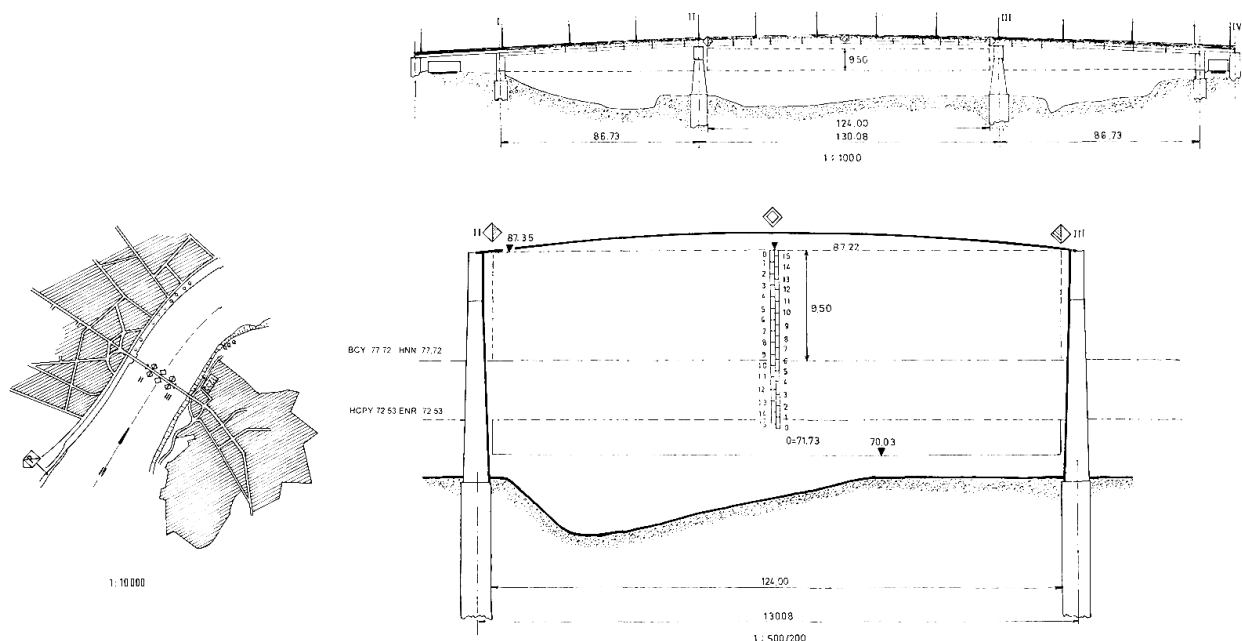
Fig. 8 The Danube – Navigable line: 1255 km – "VARADINSKA DUGA" - Novi Sad

It was anticipated that the new bridge was to be of steel construction and made in the style of “steel continual beam”. The main stages were:

- Making the bridge steel construction which includes:
  - Workshop documentation according to the main project;
  - Supply, manufacture, probationary assembling, anti corrosive protection and transport to the final location (around 290 km);
  - Assembling the construction
  - Provision and mounting the bearings and dilatations;
- Manufacturing new and repairing of old pillars;
- Insulation and asphalt works on road, pedestrian and bicycle lanes.

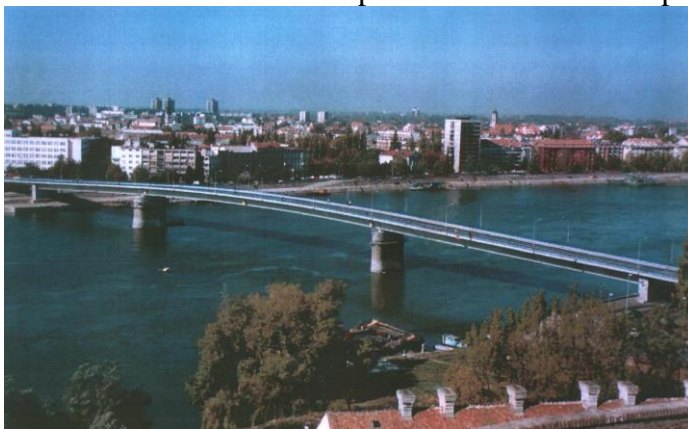
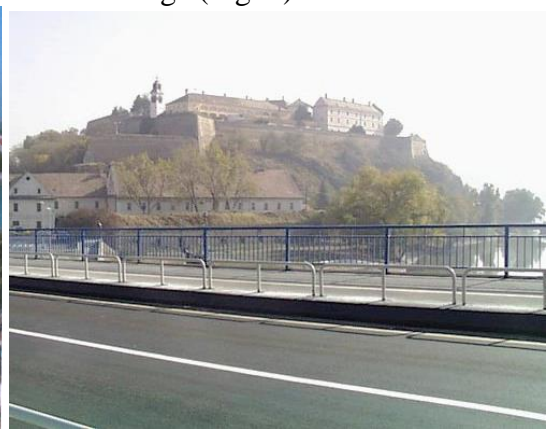
*Fig 9. Bridge “Varadinska duga“, a view of Novi Sad*

For the new highroad bridge over the Danube, at the location of the former Varadin Bridge, “Varadinska duga” (Varadin’s Rainbow), a construction documentation was made, and more than 550 tons of steel were incorporated into the central part of the bridge (Fig. 9)

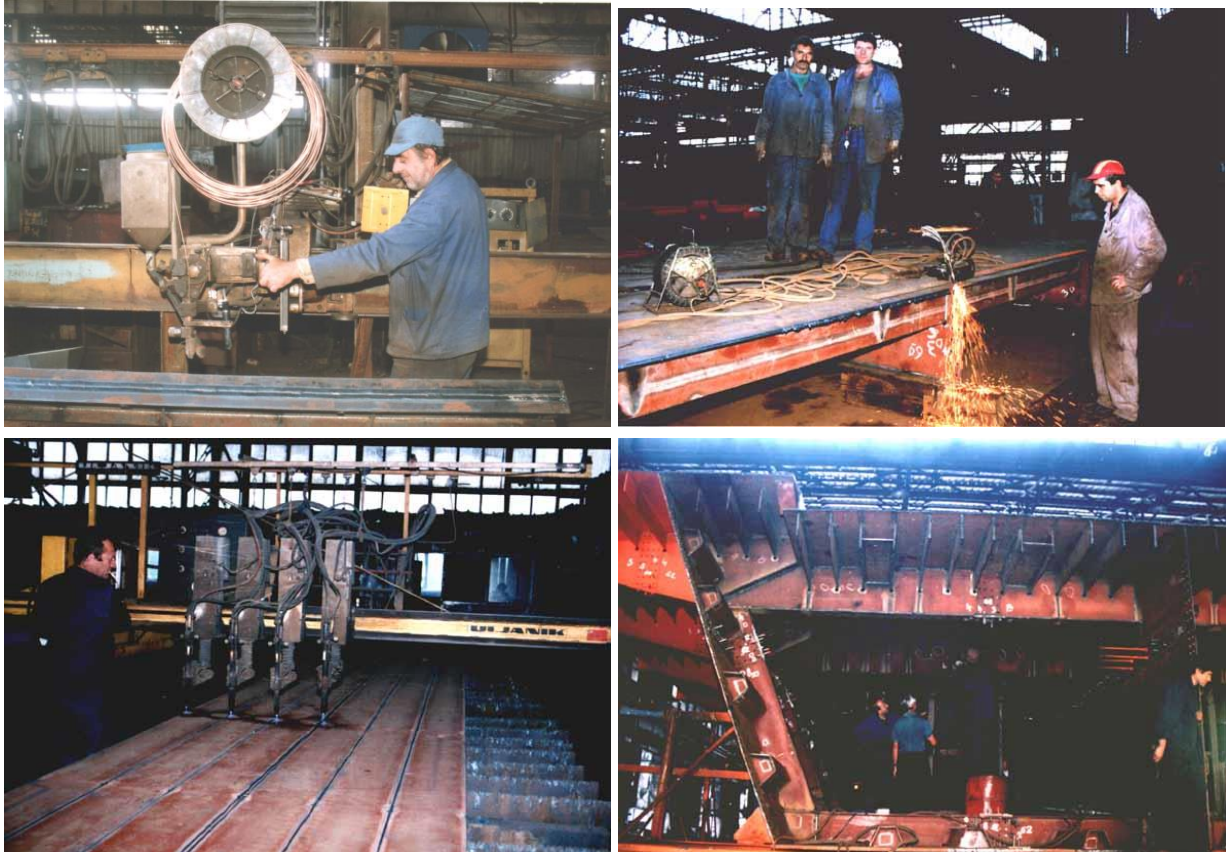
*Fig. 10 Details from the production of the elements of welding construction of the “Varadinska duga” bridge in production halls of IMK “14. oktobar” AD Krusevac*

Fig. 10 presents some details from the production hall during the production of the elements of bridge construction and probationary assembling of the “Varadinska duga” Bridge.

Analyzing the production of welded constructions, as well as the production of the “Varadinska Duga” Bridge, it has been noticed that welding and similar processes take an important role. They take up over 70% of all works in production of welded constructions. The most frequent are the following operations:

- Manual gas cutting and welding by using mixtures of acetylene-oxygen and propane-butane-oxygen;
- Machine gas cutting by using firing mixtures of acetylene-oxygen and propane-butane-oxygen;
- Manual and machine plasma cutting;
- Laser cutting by CO<sub>2</sub> lasers;
- Manual electric arc welding;
- MIG/MAG welding;
- TIG/WIG welding;
- Metallization;
- Resistance welding.

After completing the bridge components in the factory, probationary assembling took place, and then the bridge was dismantled and transported to today’s location. In every bridge building, the most delicate is the operation of lifting the bridge construction, and its positioning at the desired site. This part of the job was done by the specialized enterprise and main contractor “Mostogradnja” AD – Beograd. Thanks to the applied methodology and full control of materials, processes and the final product, the steel construction of the bridge was made with great precision and in good quality, so the final mounting was finished without any noticeable problems.
